FLASHPOINT

What price self-certification.	2
Firefighters not impressed.	3
Shake proves precautions at chemistry faculty.	4
Quakes shocks moths out of preparedness.	8
Defining hazardous area zones.	10
Cylinder survival in quake zone.	13
Uncle Archie.	14
200 years of coping with methane	15

Flashpoint is the official journal of the NZ Institute of Hazardous Substances Management.

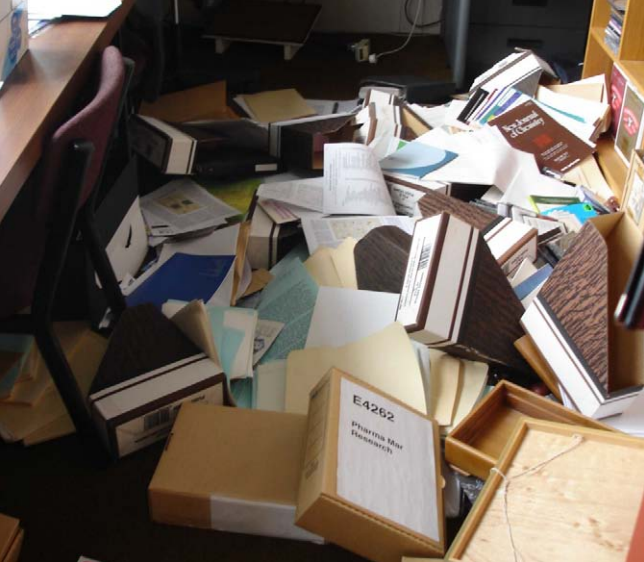
Superficial mess in an upper-floor office.

On the Monday, senior technician Wayne Mackay and I were given the tasks of performing a more detailed assessment and formulating a recovery plan. From the fifth floor down (mostly administration and the teaching laboratories) damage was negligible; but it was significant and progressively worse on the three higher floors. Books, computer monitors, pot plants and filing cabinets were strewn around offices.

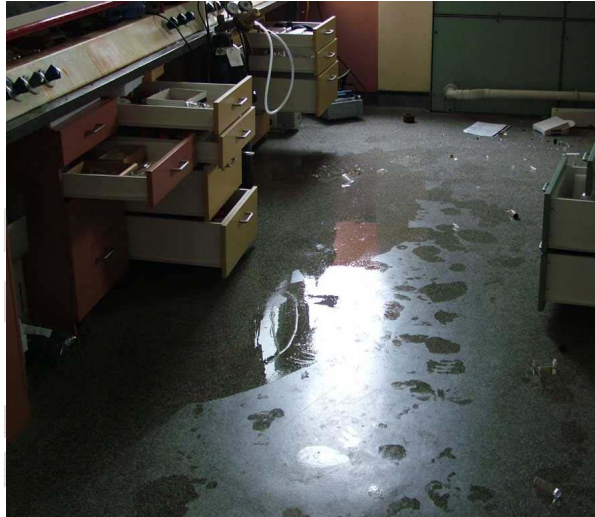
Wheeled storage cabinets in research laboratories had migrated by as much as several metres. All of the cabinets in this photo had originally been under fumehoods or benches.

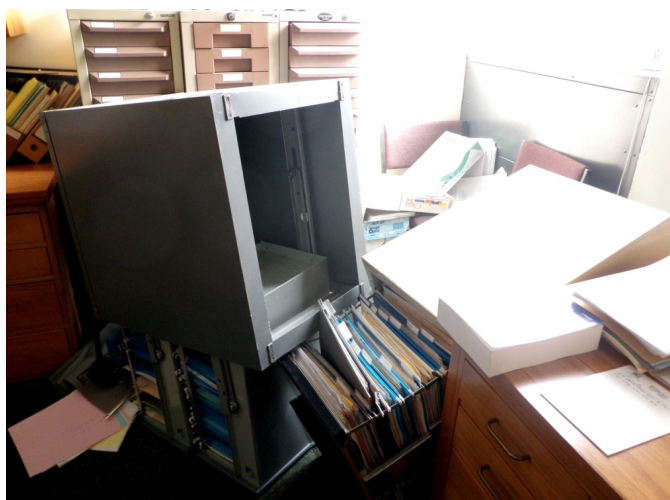
A consequence of stacked filing cabinets. Toppled cabinets would have presented significant threat to personnel if offices had been occupied during the earthquake.

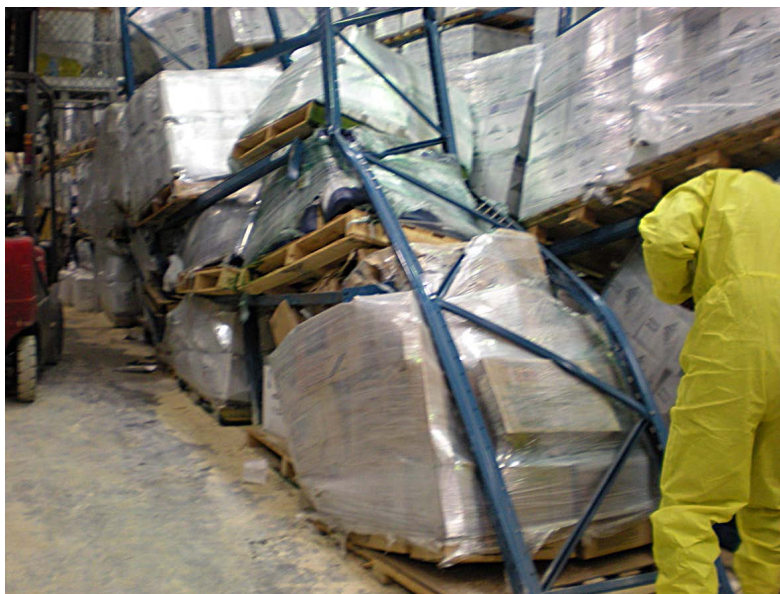
Failed and collapsed storage meant mingling of goods with unknown consequences.

national company with some hazardous chemicals stored in transit in a transport operator's warehouse. Racking in the warehouse failed during the earthquake, spilling a large quantity of liquid hazardous substances onto the surrounding warehouse floor.

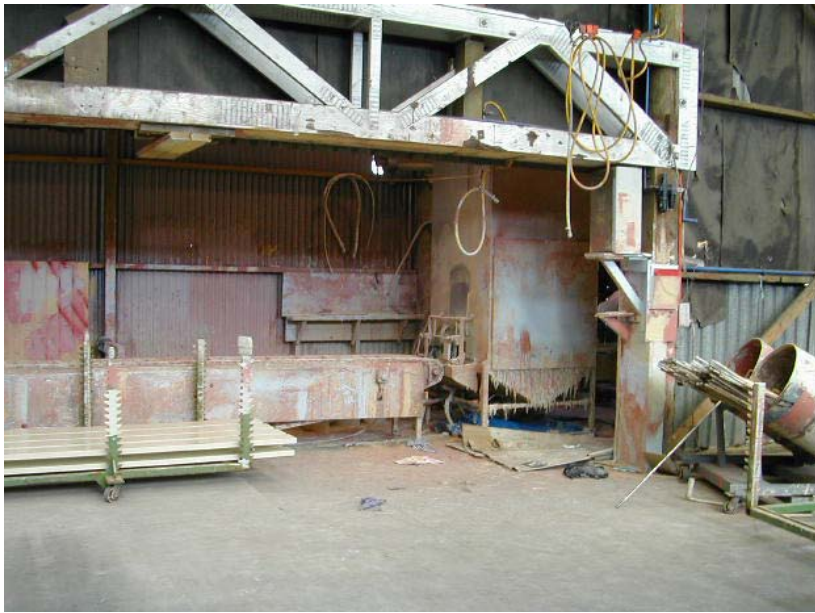
A board spray painting unit, together with the appropriate area classification drawing.

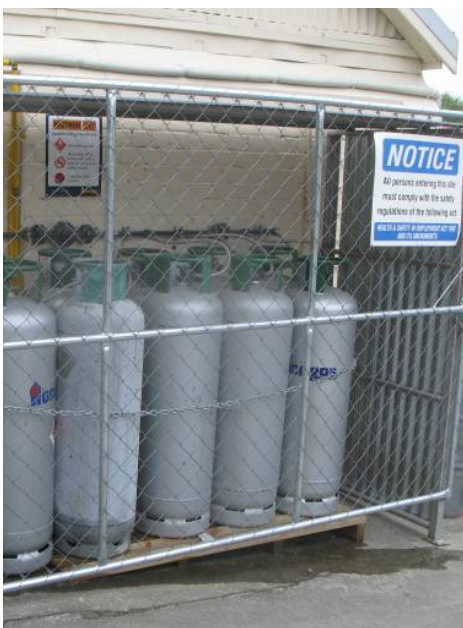
The properly restrained and caged LPG cylinders were unaffected by the earthquake.

Guess what? Management actually took my advice! The cylinders were restrained and caged within a couple of days. This response probably prevented a catastrophic fire for the mill and the nearby houses early on the morning of Saturday 4th September.

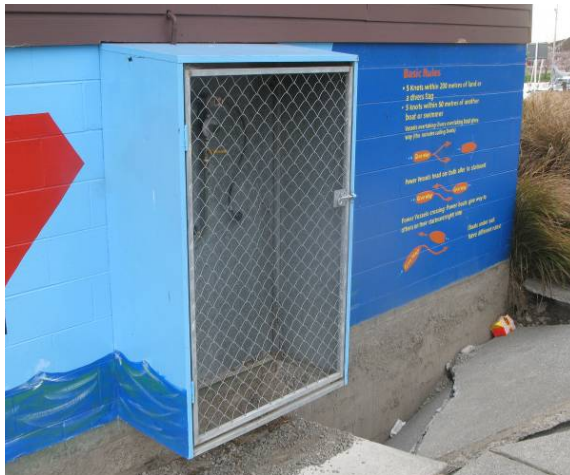
The concrete smashed and the LPG cylinders dropped by approx 450mm.

Two 45 kg LPG cylinders at the Kaiapoi Lifeboat building were stored in a small cage attached to an outside wall. When the earthquake struck, the concrete footpath broke up and dropped away. Fortunately, there was just enough slack in the LPG hoses to accommodate this 450 mm drop.

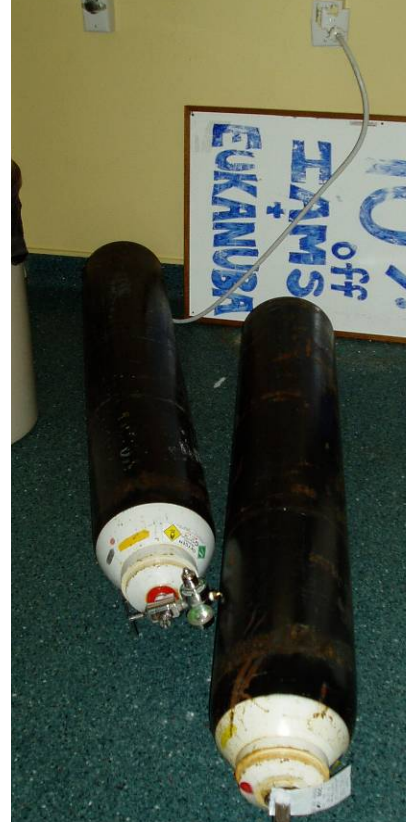
On the night in question, my little dog was in cage at one of the local vets, recovering from surgery. Two oxygen cylinders were being stored in the recovery room. The cylinders were unrestrained and had a 240 volt power lead installed across in front of them. When the earthquake struck, the cylinders crashed to the floor, half ripping the socket out of the wall. Fortunately no further damage

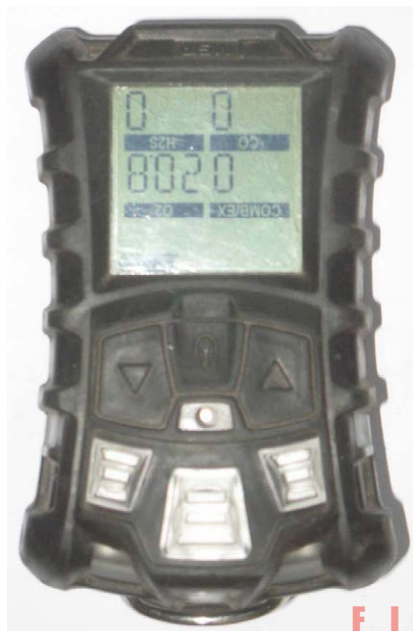
Portable gas detectors:

Modern day coal miners carry a small, highly-sensitive gas detector that emits a high-pitched beep when even minute traces of explosive gas are present in the

atmosphere. This instrument also monitors CO, H₂S and oxygen levels.
